Property Inspection Report

True Safe Home Inspections

207 Sugar Tree Lane
Inspection Prepared For: Veronica Bryan
Agent: unknown -

Date of Inspection: 2/6/2026
Year Built: 1995 Size: 2400
Weather: Sunny

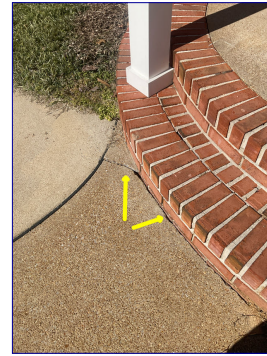
Minor cracking in walkway at front porch step area. Recommend sealing area that is cracked to help prevent future damage.

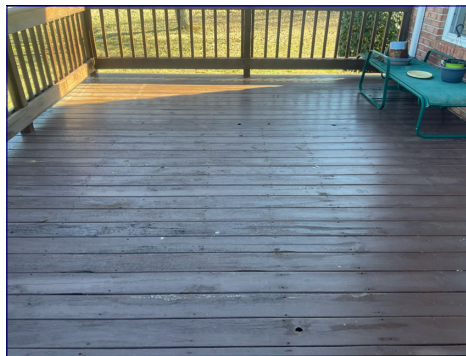
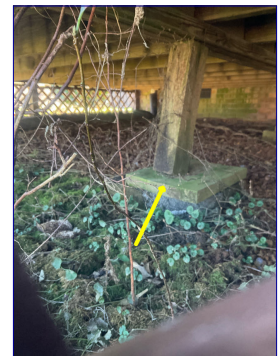
Center deck support is leaning at north side of deck. Recommend post be realigned to support the deck area

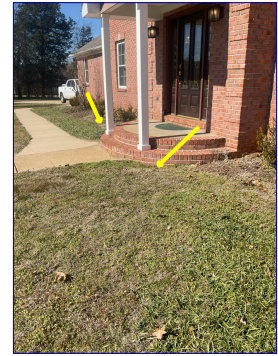
Water is ponding at each side of front porch area steps. Recommend additional backfill be added.

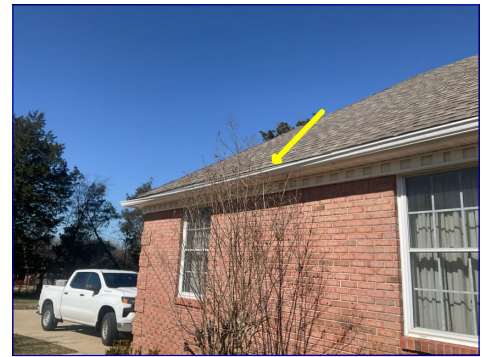
Gutter attachment at Southside of garage area will need to be re-secured and also drip edge flashing will need to be reinstalled and secured under shingles.

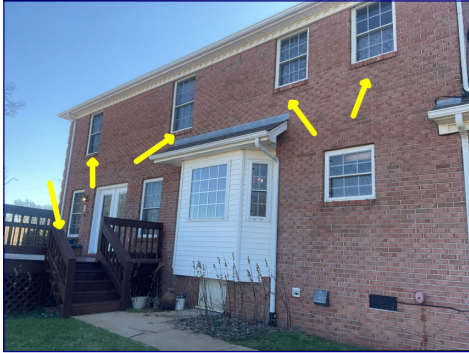
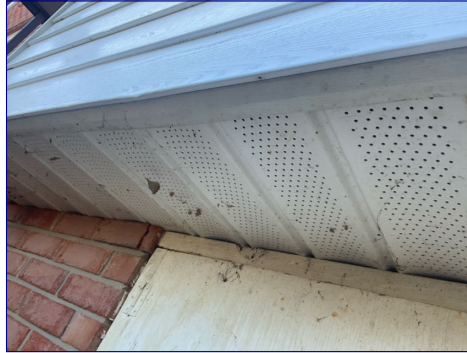
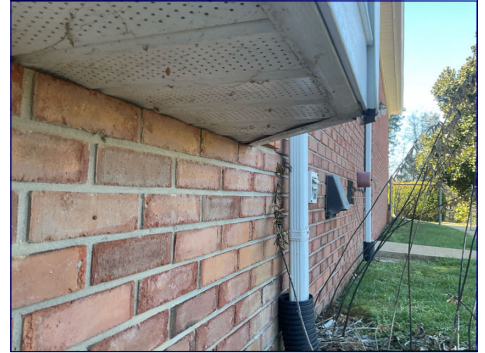
Grout joints below windows at sill located north side of house will need to be touched up. Recommend re-grouting brick joints.

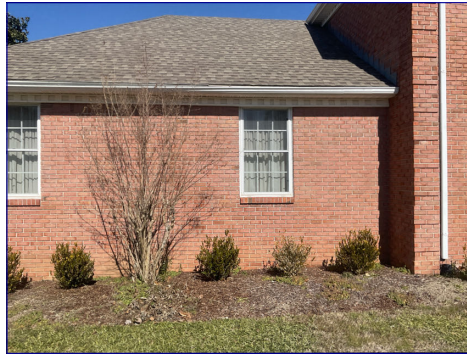
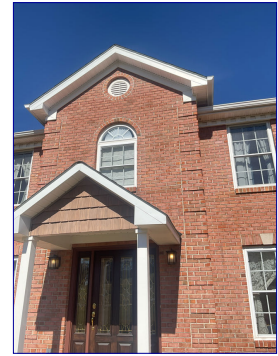
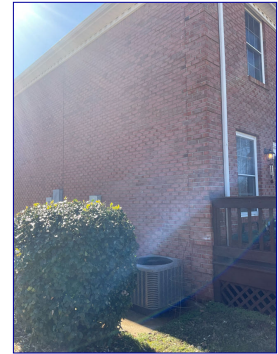
Brick siding mortar joint at Northeast corner step out will need to be sealed in areas. Recommend contractor evaluate and make necessary repairs.

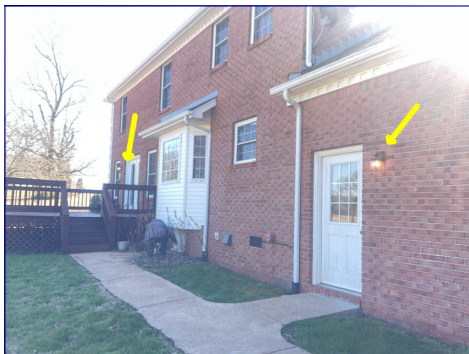
Recommend caulking above light fixtures, and receptacle outlet at southside of house.

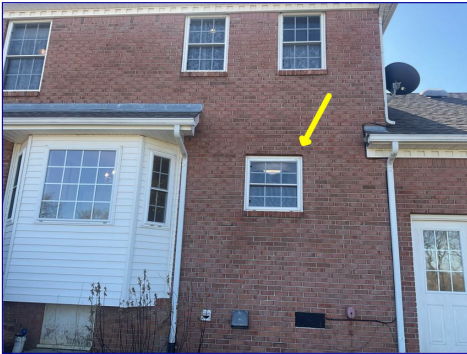
Window plastic trim for exterior window located at rear of house (kitchen window) has small area missing. Repair as necessary

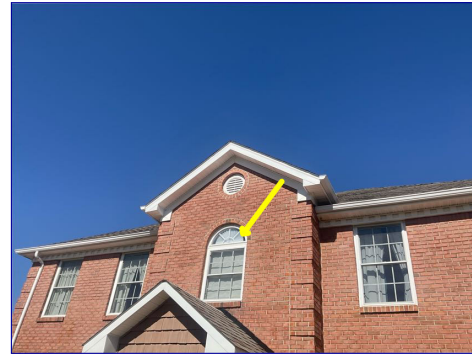
Half moon window above front porch area had paint peeling on interior trim. Recommend this area be evaluated for moisture intrusion. Thermal camera didn't show any signs of moisture at time of inspection. Monitor this area and repair as necessary.

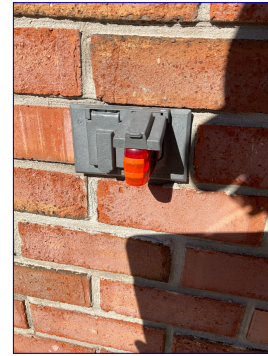
Exterior receptacle at deck area is not protected. Recommend electrician evaluate and make necessary repairs for GFI protection.

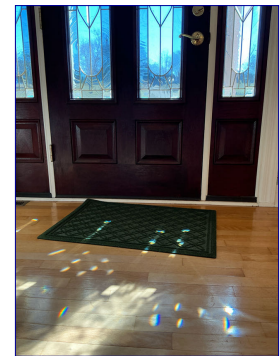
Area at bottom of front door where air is able to enter the home. Recommend contractor make necessary repairs.

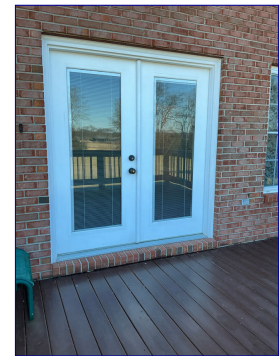
Unable to lock door handle of back door. Recommend contractor make necessary repairs.

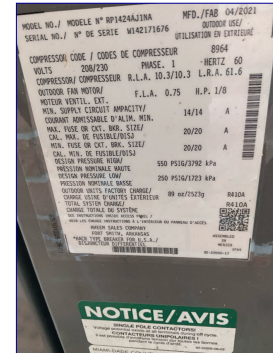
Suction line for split unit condenser will need to have line insulation replaced. Insulation is missing.

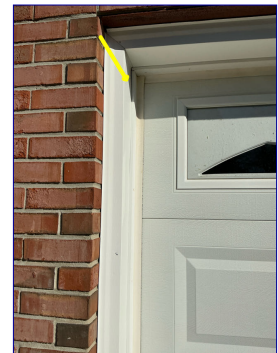
Loose trim at outside garage overhead door. Recommend contractor make necessary repairs.

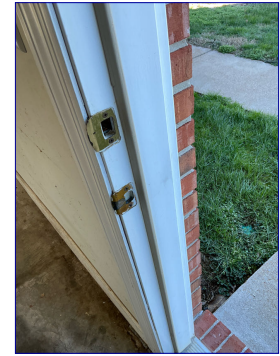
Unable to lock the door handle in the garage exterior door. Recommend contractor make necessary repairs.

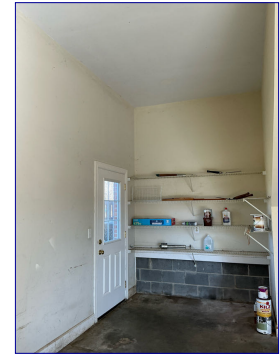
Small hole in garage wall. Recommend contractor make necessary repairs.

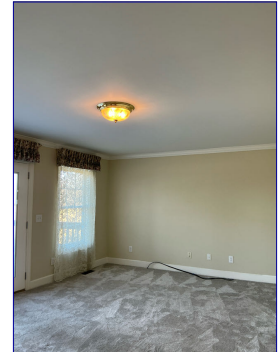
Crack in the corner wall from ceiling to floor in the family room. Recommend contractor make necessary repairs.

Small crack in the northeast corner wall of the family room area. Recommend monitoring and repairing as needed.

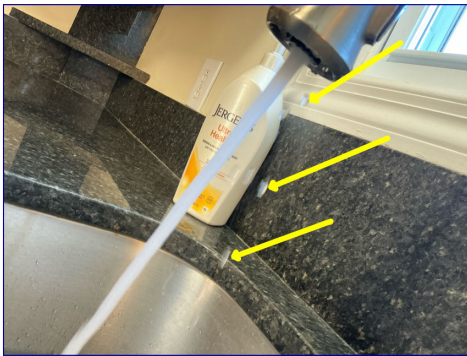
Dripping in areas of kitchen faucet when operating. Recommend plumber make necessary repairs.

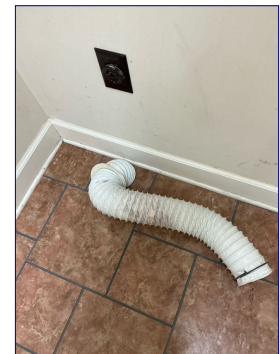
Dryer vent pipe in the crawlspace is plastic flexible pipe meeting flexible hard pipe. Recommend changing plastic flexible pipe to solid metal pipe. Flexible pipe can only be used indoors.

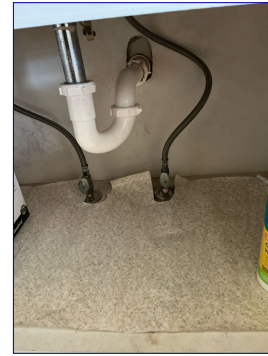
Faucet in first floor half bath is loose. Recommend plumber make necessary repairs.

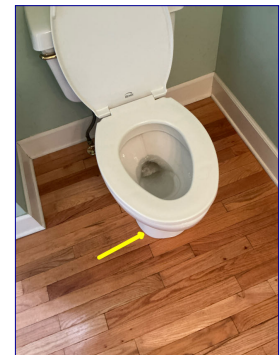
Toilet in first floor half bath is loose. Recommend plumber make necessary repairs.

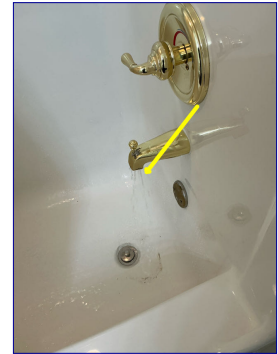
The shower diverter in second floor guest bathroom shower doesn't work correctly. Recommend further evaluation and repair by a licensed plumber.

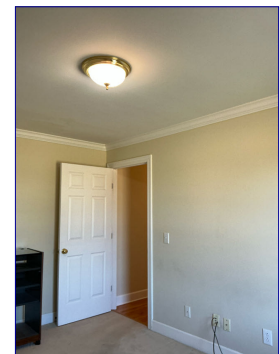
Typical crack in the northeast guest bedroom. Recommend monitoring and repairing as needed.

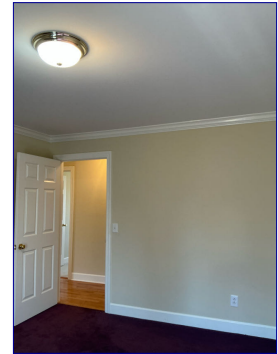
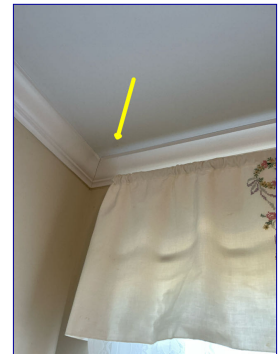
Moisture stain on the ceiling of the north west guest bedroom. No moisture was detected at time of inspection. Recommend monitoring and repairing as needed.

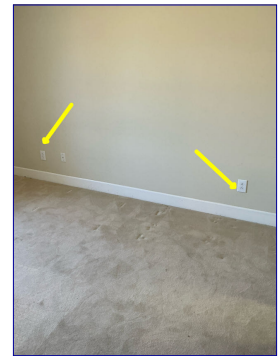
There are several loose receptacles in the northeast guest bedroom. Recommend electrician make necessary repairs.

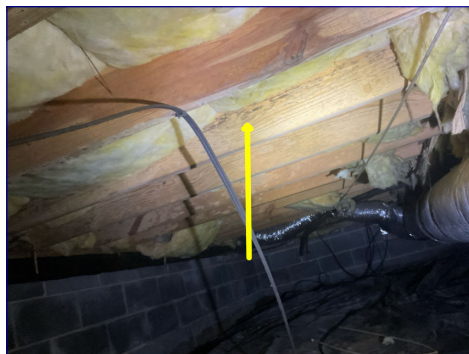
There is an organic growth like substance noticed in the crawlspace at the joists. Recommend a professional environmental company test and remediate as needed.

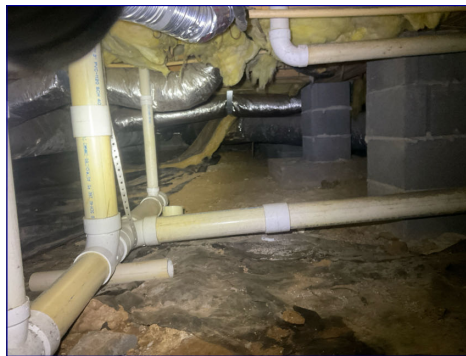
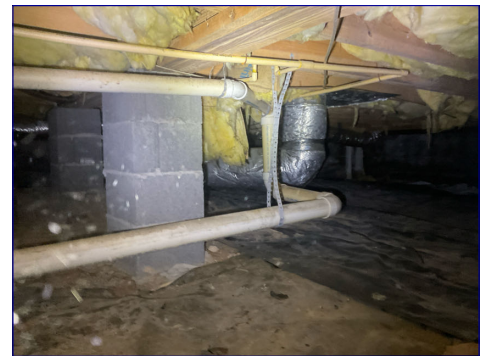
Insulation in the crawlspace is falling in some areas. Recommend having insulation placed back between floor joists.

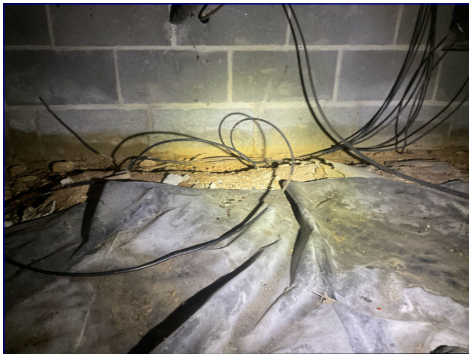
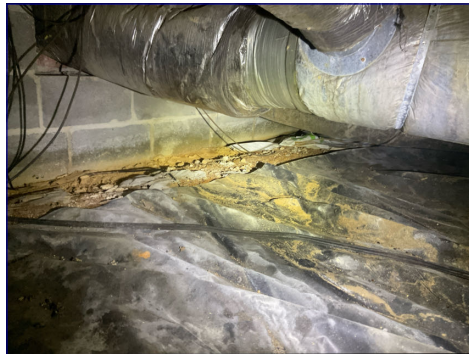
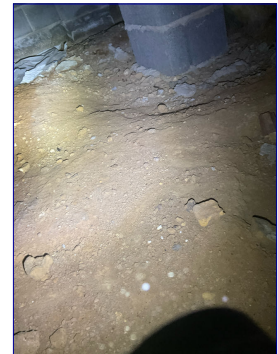
The vapor barrier is missing or damaged on the crawlspace floor. The vapor barrier is used to prevent ground moisture from moving up and into the living area of the home. Recommend a licensed contractor install a proper vapor barrier.

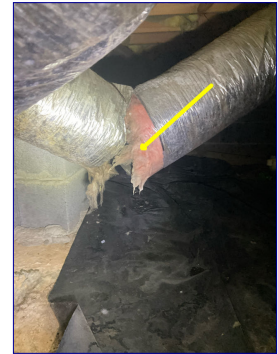
Flex Ductwork, that looks to be going to laundry room will need to be replaced or repaired with metal coupling in the crawlspace. Recommend contractor make necessary repairs.

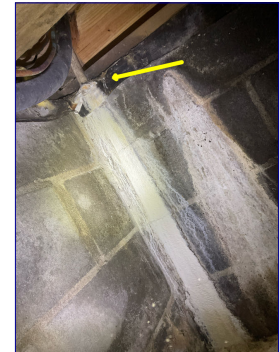
Recommend installing secondary drain safety switch for secondary drain port for HVAC unit in the attic. This will keep water from entering the draining pan if condensate trap for main drain becomes clogged. Recommend this be done at next HVAC service.

Condensate line for HVAC unit in the attic terminates in the crawlspace. recommend contractor terminate condensate line to exterior of home.
