Property Inspection Report

True Safe Home Inspections

207 Sugar Tree Lane
Inspection Prepared For: Veronica Bryan
Agent: unknown -

Date of Inspection: 2/6/2026
Year Built: 1995 Size: 2400
Weather: Sunny

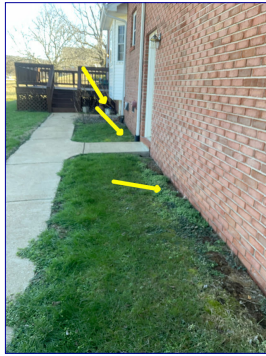
There is a negative grading slope, toward the foundation, in one or more locations. Recommend maintaining a positive drainage slope away from the foundation. Consult a professional landscaper for proper drainage and grading as needed.

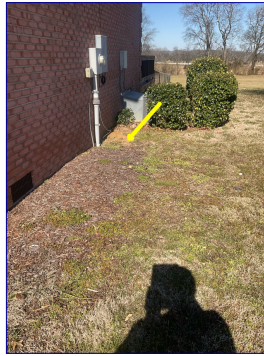
Water is ponding at foundation located by electrical meter base. Recommend additional backfill so water will drain properly from foundation.

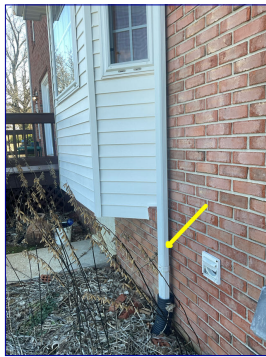
Gutter downspout beside dryer vent hood needs to be secured to siding.

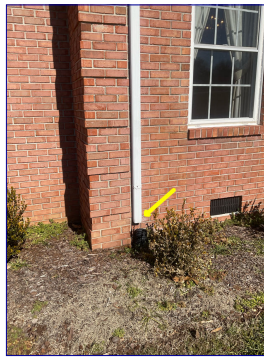
Gutter downspout at south side of house is not discharging water away from foundation properly. Recommend downspout be extended to flex drainage pipe.

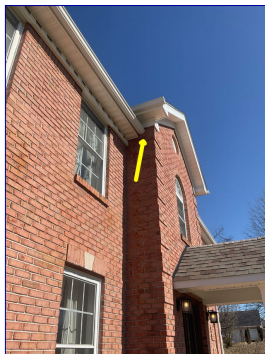
Gutter attachment above front porch area located at West side of porch area will need to be secured. Gutter is not pitched properly.

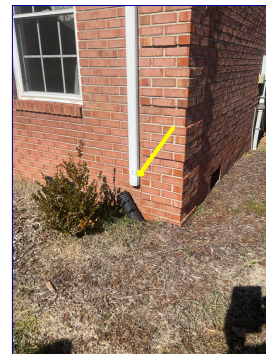
Gutter downspout at Southeast corner of house is not directing water away from the foundation. Recommend attaching back to black flex drain pipe.

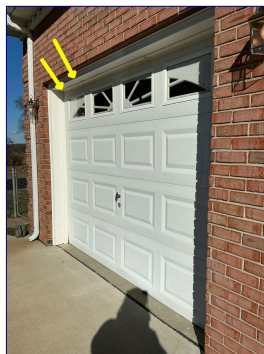
Area of wavy trim at garage door. Recommend contractor make necessary repairs.

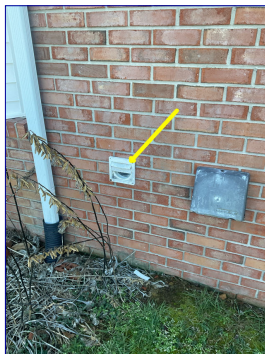
Dryer exterior vent hood will need to be replaced.

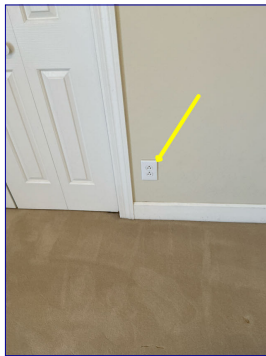
Loose receptacle on the east wall of the north west guest bedroom. Recommend electrician make necessary repairs.

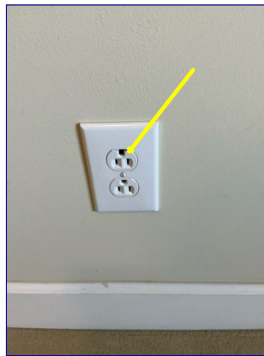
Loose and broken receptacle in northeast guest bedroom. Recommend electrician replace receptacle.

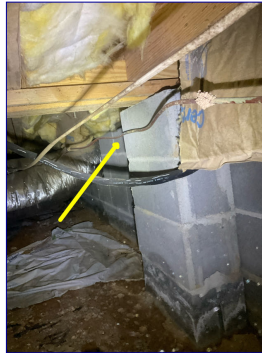
Copper gas line in the crawlspace will need to be secured floor joists if gas is installed.
