Property Inspection Report

True Safe Home Inspections

207 Sugar Tree Lane
Inspection Prepared For: Veronica Bryan
Agent: unknown -

Date of Inspection: 2/6/2026
Year Built: 1995 Size: 2400
Weather: Sunny

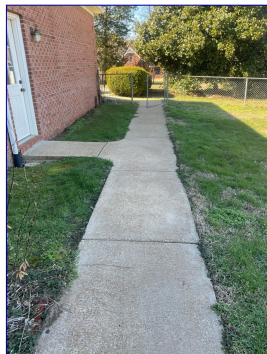
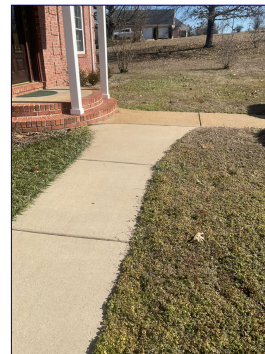
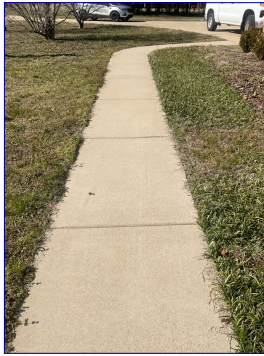
Minor cracking in walkway at front porch step area. Recommend sealing area that is cracked to help prevent future damage.

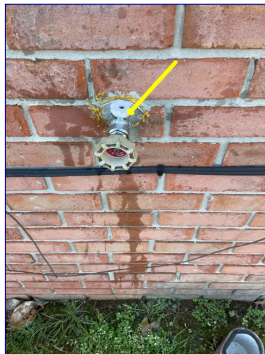
Frostproof hose bib at north side of house is leaking at the vacuum breaker. Recommend plumber repair leak and replace cap for vacuum breaker

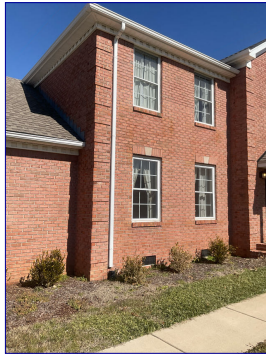
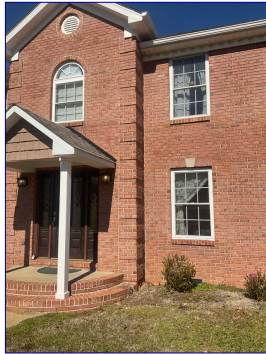
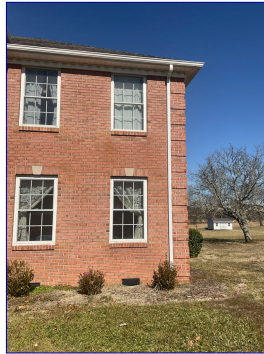
Brick siding mortar joint at Northeast corner step out will need to be sealed in areas. Recommend contractor evaluate and make necessary repairs.

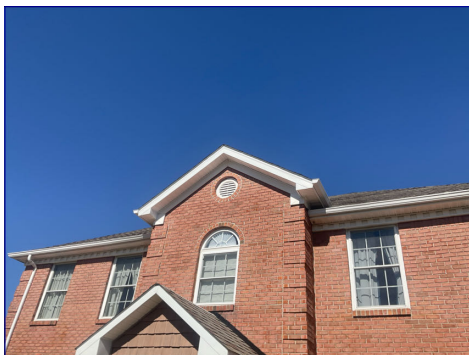
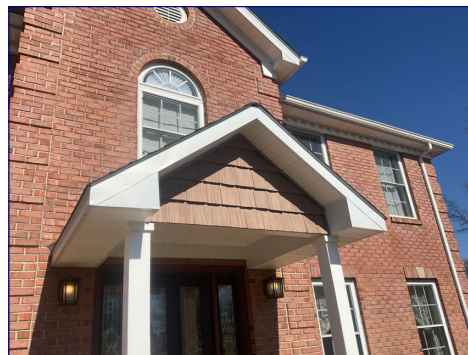
Recommend caulking above light fixtures, and receptacle outlet at southside of house.

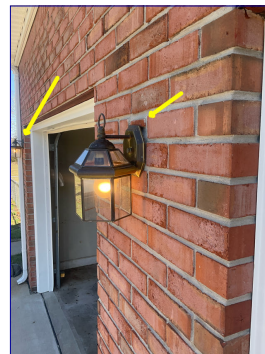
Recommend caulking above light fixtures at garage front and also center light fixture is loose recommend securing light fixture

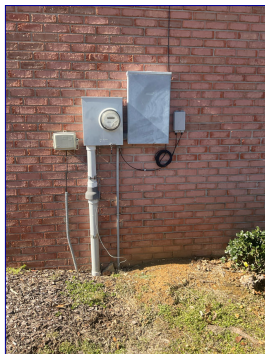
Main lug at exterior electrical panel beside meter base is loose. recommend electrician make necessary repairs.

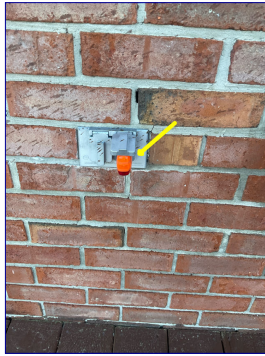
Exterior receptacle at deck area is not protected. Recommend electrician evaluate and make necessary repairs for GFI protection.

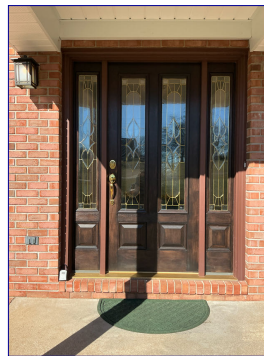
Area at bottom of front door where air is able to enter the home. Recommend contractor make necessary repairs.

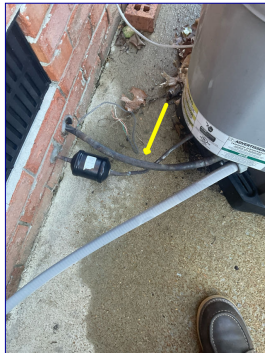
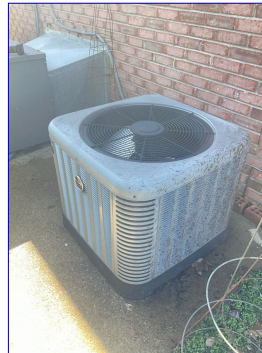
Suction line for split unit condenser will need to have line insulation replaced. Insulation is missing.

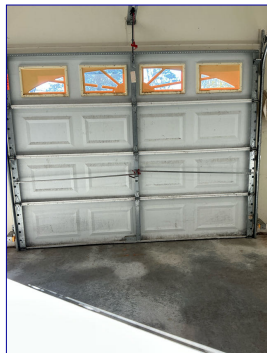
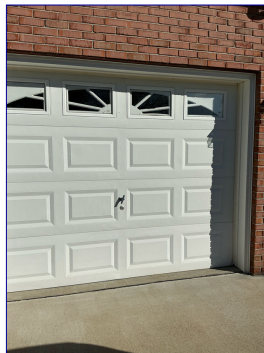
Loose trim at outside garage overhead door. Recommend contractor make necessary repairs.

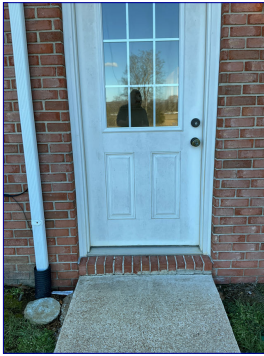
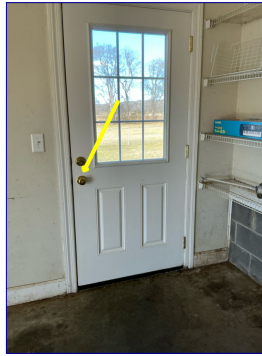
Unable to lock the door handle in the garage exterior door. Recommend contractor make necessary repairs.

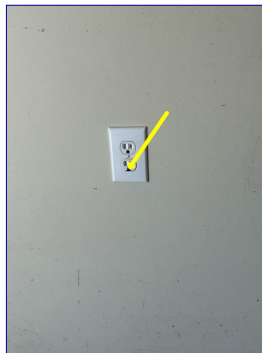
Broken receptacle in the garage. Recommend electrician replace receptacle.

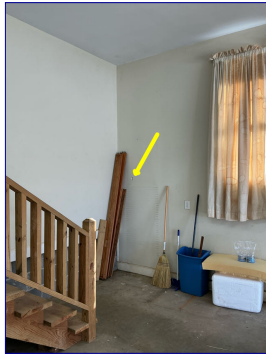
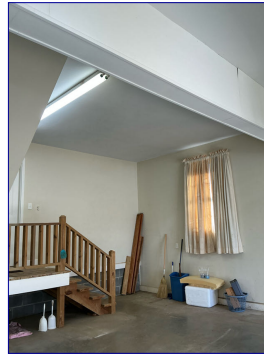
Small hole in garage wall. Recommend contractor make necessary repairs.

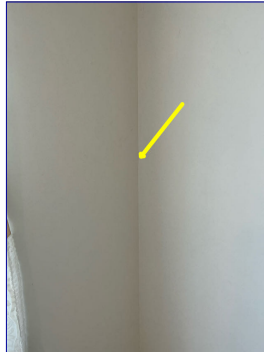
Crack in the corner wall from ceiling to floor in the family room. Recommend contractor make necessary repairs.

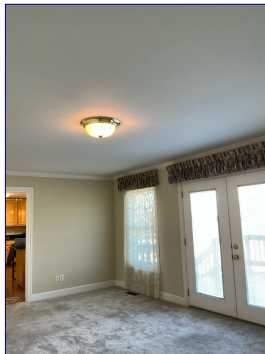
Small crack in the northeast corner wall of the family room area. Recommend monitoring and repairing as needed.

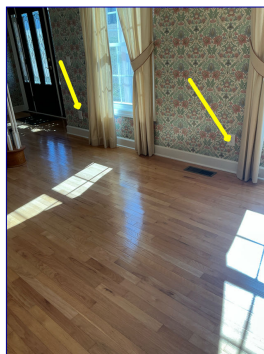
There are several loose receptacles in the dining room area. Recommend electrician make necessary adjustments.

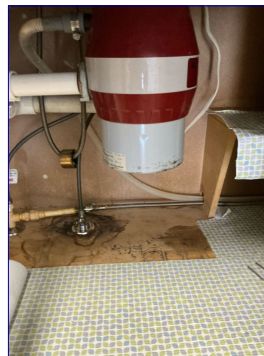
Dripping in areas of kitchen faucet when operating. Recommend plumber make necessary repairs.

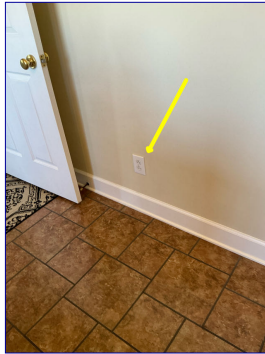
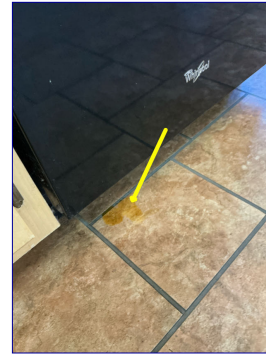
Leak at kitchen dishwasher door seal. Recommend plumber further evaluate and make necessary repairs.

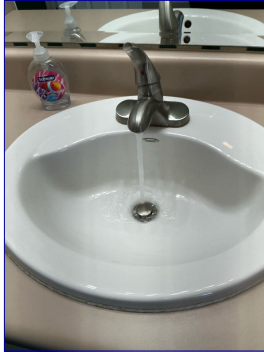
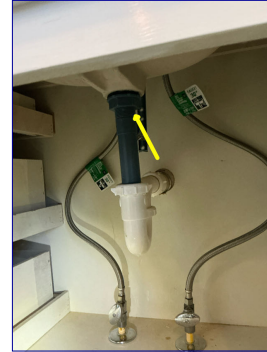
Drainage leak at master bathroom sink. Recommend plumber make necessary repairs.

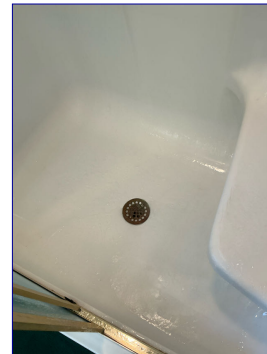
Master bathroom shower head is leaking. Recommend plumber make necessary repairs.

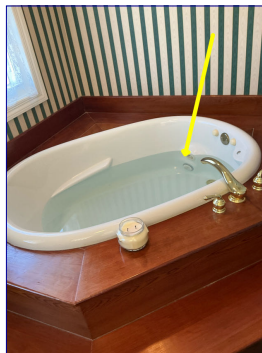
Whirlpool was not operational at time of inspection. Recommend plumber further evaluate and make all necessary repairs.

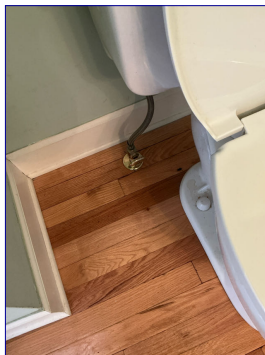
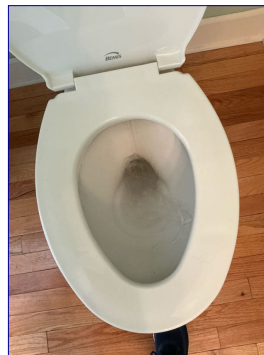
Toilet in first floor half bath is loose. Recommend plumber make necessary repairs.

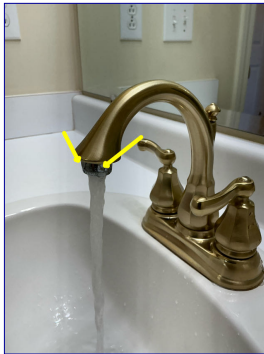
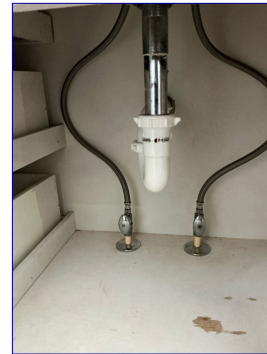
Faucet is leaking in second floor guest bathroom. Recommend plumber further evaluate and make necessary repairs.

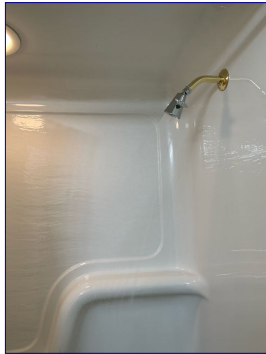
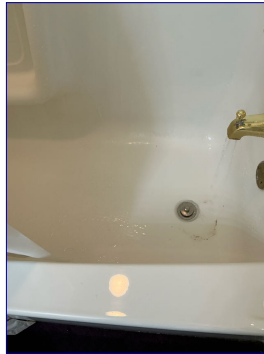
The shower diverter in second floor guest bathroom shower doesn't work correctly. Recommend further evaluation and repair by a licensed plumber.

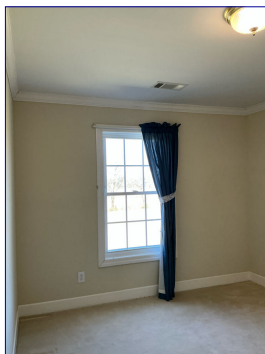
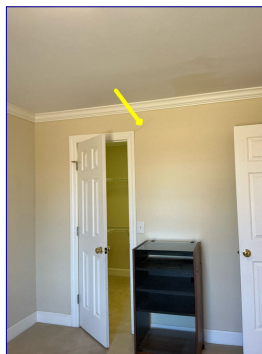
Typical crack in the northeast guest bedroom. Recommend monitoring and repairing as needed.

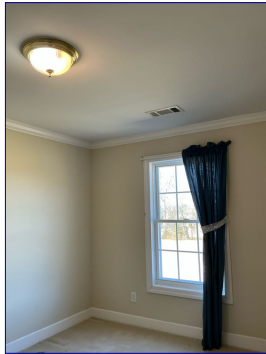
Moisture stain on the ceiling of the north west guest bedroom. No moisture was detected at time of inspection. Recommend monitoring and repairing as needed.

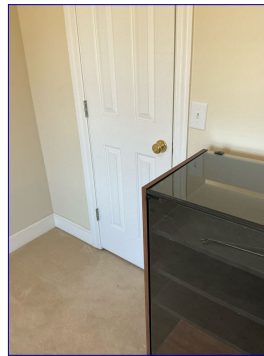
Northeast guest bedroom closet door will not latch properly. Recommend contractor make necessary adjustments.

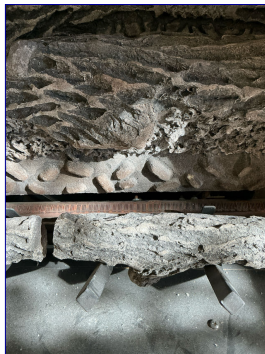
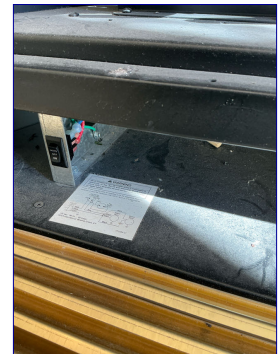
Marginal
 Observations:
 • The gas was turned off, and the fireplace could not be operated or evaluated.

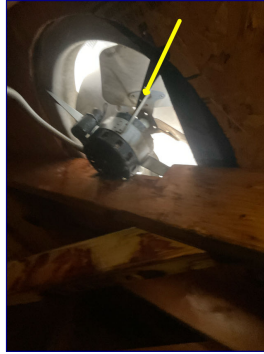
Power ventilation fan in attic area will need to have motor replaced. Recommend contractor replace motor and evaluate.

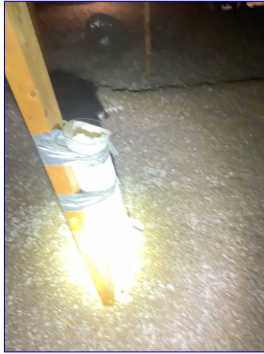
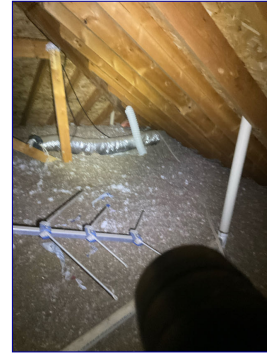
- Bathroom vents terminate in the attic. Recommend extending bathroom vents in the attic to the exterior. When home was built this was excepted. There wasn't any signs of moisture issues at time of inspection. Repair as necessary.

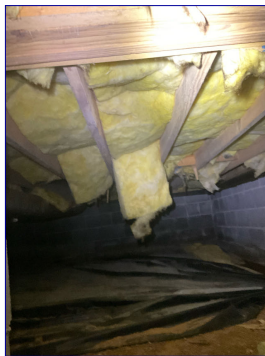
Insulation in the crawlspace is falling in some areas. Recommend having insulation placed back between floor joists.

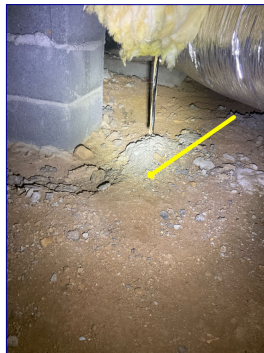
The vapor barrier is missing or damaged on the crawlspace floor. The vapor barrier is used to prevent ground moisture from moving up and into the living area of the home. Recommend a licensed contractor install a proper vapor barrier.

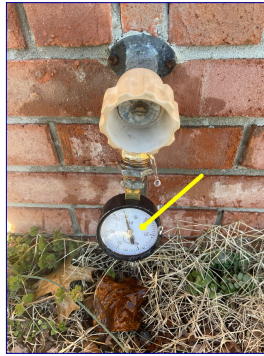
Water pressure was above 100 psi at time of inspection. Recommend plumber locate pressure regulator and make necessary repairs to lower pressure below 80 psi.

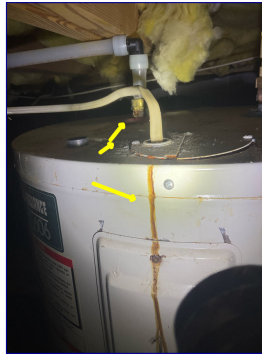
One water heat connection at hot water side has corrosion and has leaked in the past. No water was present at time of inspection. Repairs look like they have been done at some point in the past. Recommend monitoring water heater for leaks and repair or replace as needed.

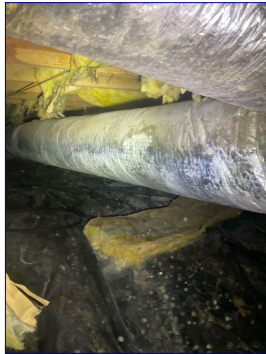
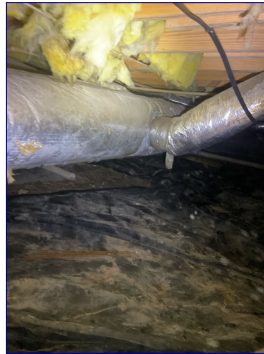
Flex Ductwork, that looks to be going to laundry room will need to be replaced or repaired with metal coupling in the crawlspace. Recommend contractor make necessary repairs.

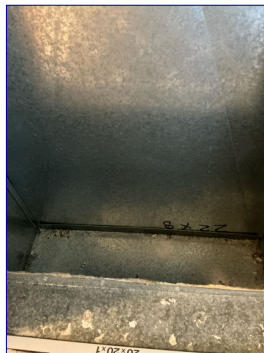
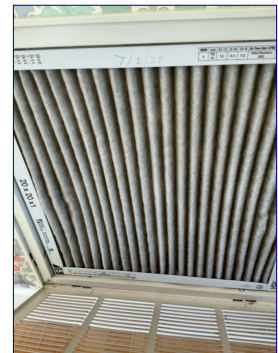
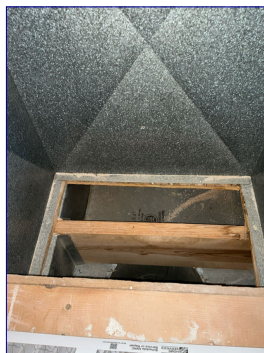
- Needs cleaning/replacement

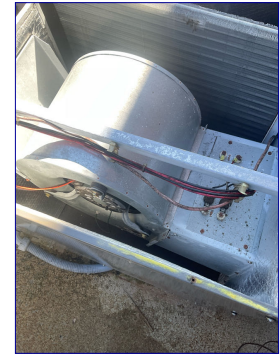
Rudd package unit evaporator coil will need to be cleaned at next HVAC service.

- Rudd package unit evaporator coil will need to be cleaned at next HVAC service.

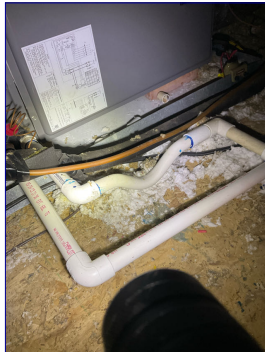
Recommend installing secondary drain safety switch for secondary drain port for HVAC unit in the attic. This will keep water from entering the draining pan if condensate trap for main drain becomes clogged. Recommend this be done at next HVAC service.

- Recommend installing secondary drain safety switch for secondary drain port for HVAC unit in the attic. This will keep water from entering the draining pan if condensate trap for main drain becomes clogged. Recommend this be done at next HVAC service.

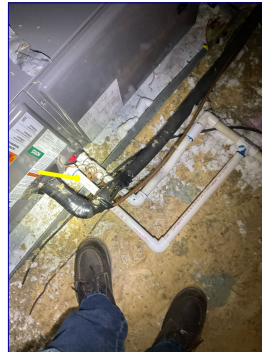
Condensate line for HVAC unit in the attic terminates in the crawlspace. recommend contractor terminate condensate line to exterior of home.

- **Condensate line for HVAC unit in the attic terminates in the crawlspace at South wall. Recommend contractor terminate condensate line to exterior of home.**
